Implant Disassembly Due to Pedicle Screw Nut Loosening

J Neurosci Rural Pract 2021;12:813–814.

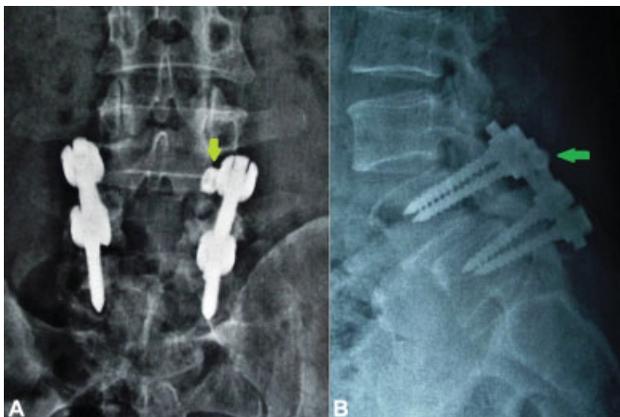
Fig. 1 (A, B) Anteroposterior and lateral skiagrams of the lumbar spine showing loosening of the inner nut (green arrows) from the left L4 pedicle screw with implant disassembly. The rod is still lying within the pedicle screw head.

Implant disassembly due to pedicle screw nut loosening is a rare complication of spinal instrumentation that predisposes to rod migration with sparse literature mostly in the form of case reports.^{1–3} The inner screw itself, after progressive loosening, may come out of the construct (as in our first case) or may continue to remain in situ (as in our second case). Causes described for screw nut loosening include both insufficient tightening of the inner nut into the pedicle screw head^{1,3} and improper coupling of the inner nut with the pedicle screw head by not squaring the corresponding threads of both the elements prior to tightening.^{1,3} The surgeon must be careful and ensure that there is no soft

tissue inside the pedicle screw head at the time of tightening the inner nut and that all nuts are completely tightened after the construct is assembled and also take care that, at the time of insertion, the threads of the inner nut match the grooves on the pedicle screw, a process easily achieved by initially rotating the nut in a counter-clockwise direction till a “click” sound is heard.

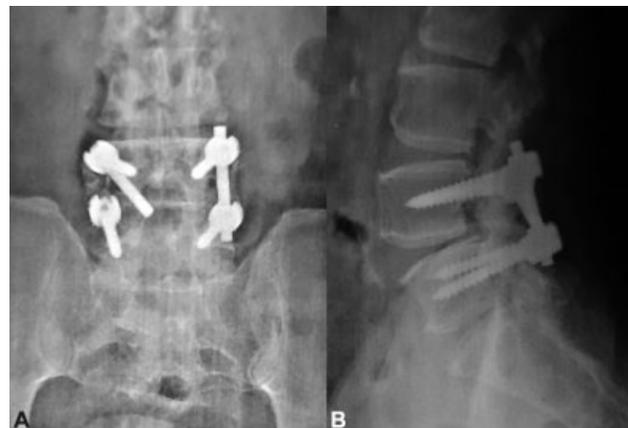
Fig. 2 (A, B) Anteroposterior and lateral skiagrams of the lumbar spine showing rod migration medially out of the right L5 pedicle screw head though the inner nut is still lying in situ.

resurgery to revise the implant but only the second patient agreed for the same.
